Case Study:

Ground Movement and Structural Deformation Monitoring using Distributed Fiber Optic Sensing

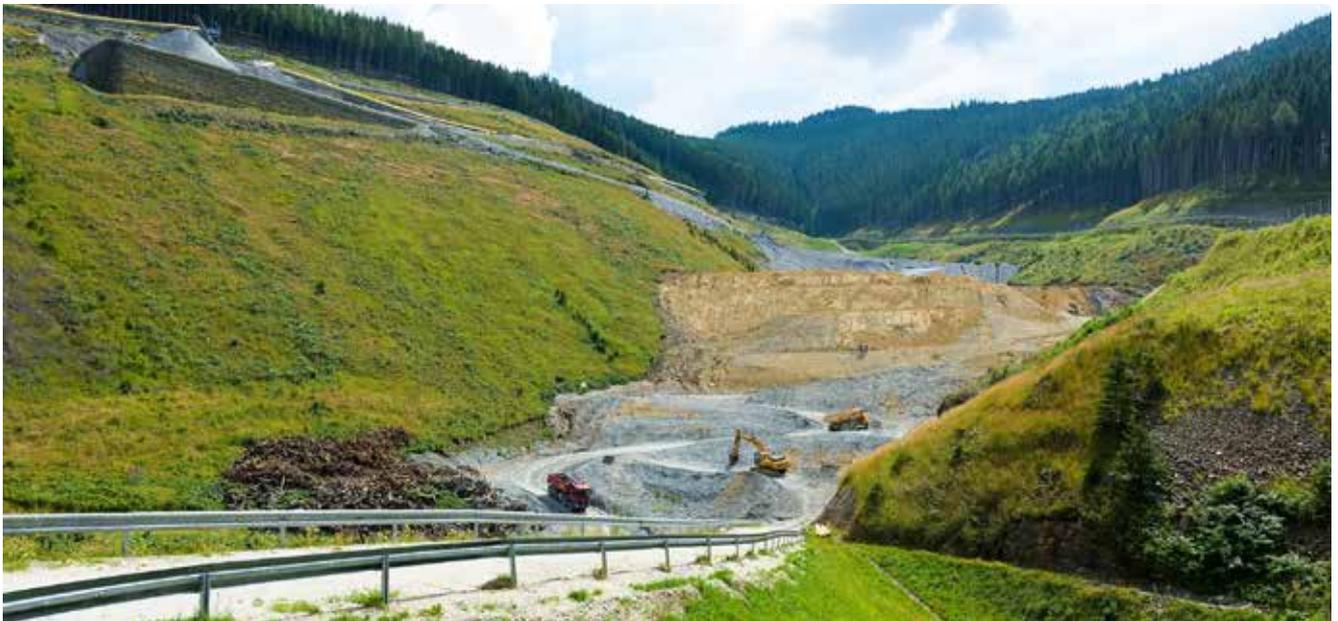
Figure 1: Longsgraben disposal site during the Semmering Base Tunnel excavation (photo © ÖBB/Ebner)

The Longsgraben valley provided the central disposal site for the 27.3 km Semmering Base Tunnel. Excavated material was transported to the 20 ha site on a 2 km conveyor belt and by truck.

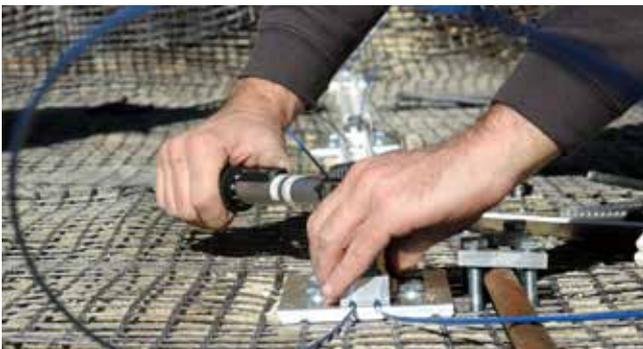
Figure 3: Attaching the fiber optic sensing cable to the geogrid

The fiber optic sensing cables were attached to geogrids using anchors and deployed at four cross-sections of the structure, at different height levels.

The strain sensing cable length was pretensioned to detect strain; the same sensing cable was used without tensioning to provide temperature compensation.

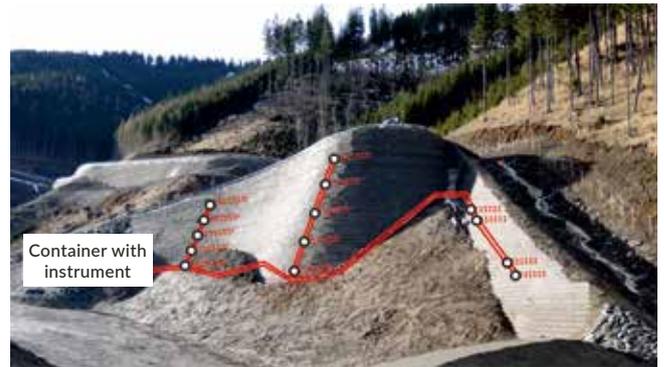
Figure 4: The geogrid and sensing cables were deployed within the earth retaining structure

At each level, a fiber optic sensing cable loop of about 2.5 km detects strain on the outward path, and temperature on the return, providing temperature compensation for the strain measurements.

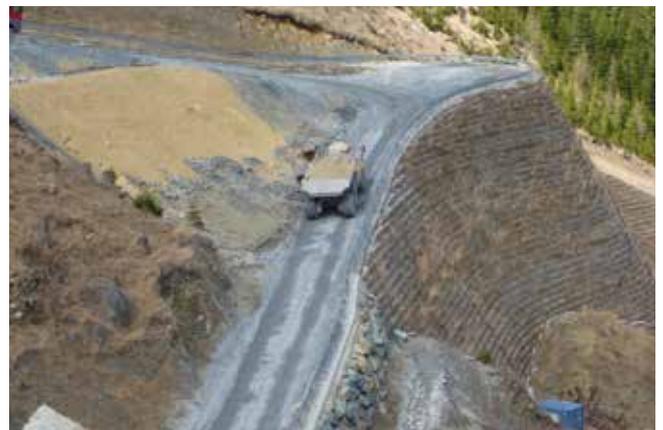
Figure 7: Adding quantities of soil to widen the access road resulted in a sudden rise in strain behind the structure

In 2017, all strain readings suddenly increased in phase C (Figure 5). An investigation revealed that to accommodate larger dump trucks, the road had been widened using extra earth (Figure 7).

The timing of the work coincided with the strain increase and the affected section was observed closely so that appropriate action could be taken if the strain development did not stabilize.
