Case Study:

Ground Movement and Structural Deformation Monitoring using Distributed Fiber Optic Sensing

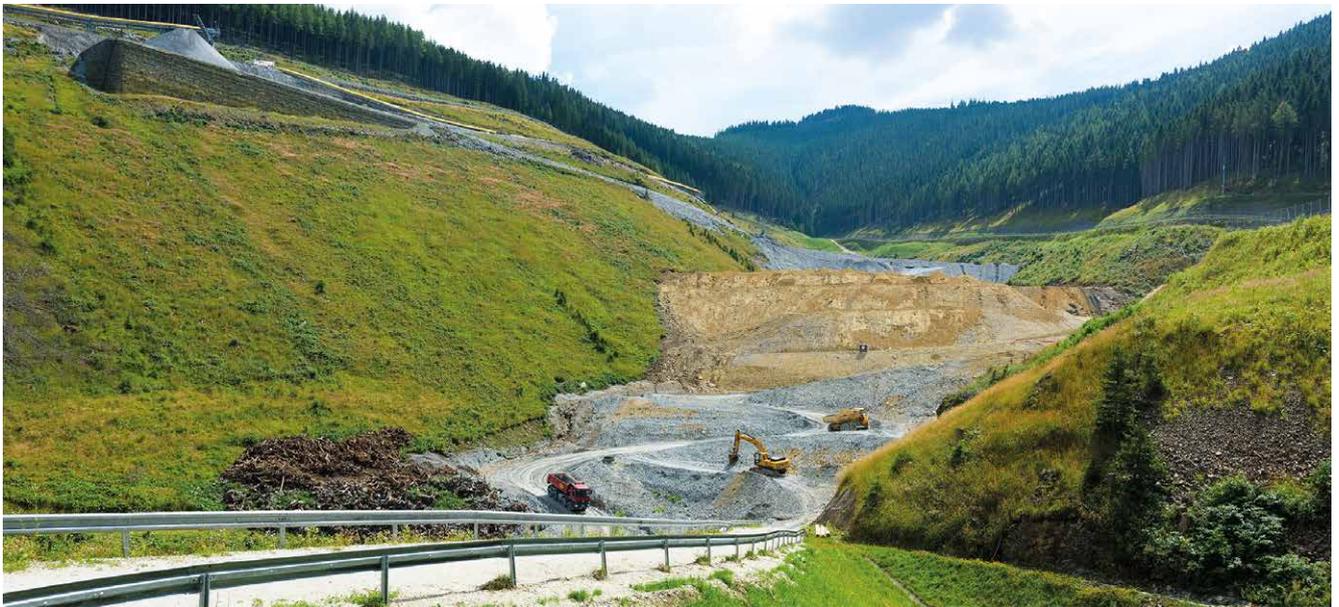
Longsgraben disposal site during the Semmering Base Tunnel excavation (photo courtesy Austrian Federal Railways © ÖBB/Ebner)

The Longsgraben valley provided the central disposal site for the 27.3 km Semmering Base Tunnel. Excavated material was transported to the 20 ha site on a 2 km conveyor belt and by truck.

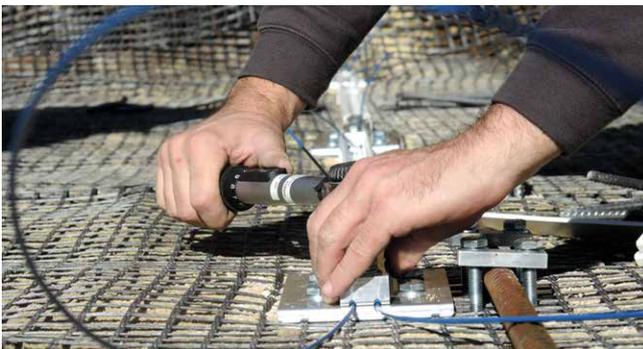
Figure 3: Attaching the fiber optic sensing cable to the geogrid

The fiber optic sensing cables were attached to geogrids using anchors and deployed at four cross-sections of the structure, at different height levels.

The strain sensing cable length was pretensioned to detect strain; the same sensing cable was used without tensioning to provide temperature compensation.

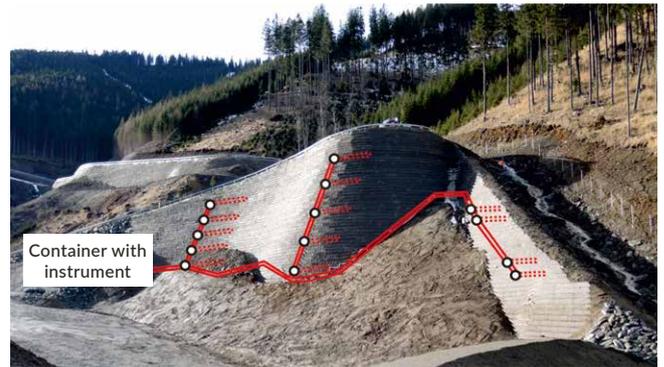
Figure 4: The geogrid and sensing cables were deployed within the earth retaining structure

At each level, a fiber optic sensing cable loop of about 2.5 km detects strain on the outward path, and temperature on the return, providing temperature compensation for the strain measurements.

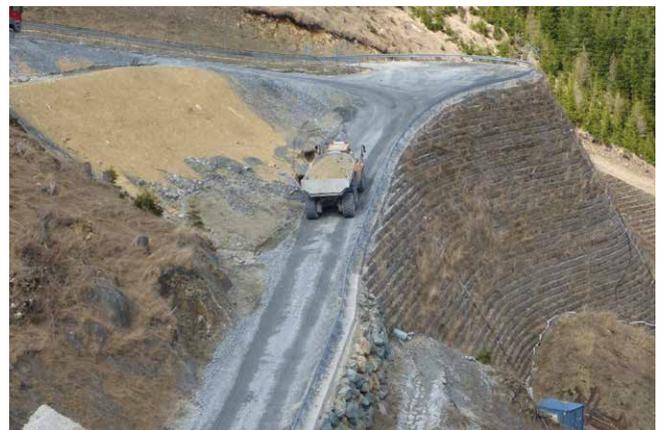
Figure 7: Adding quantities of soil to widen the access road resulted in a sudden rise in strain behind the structure

In 2017, all strain readings suddenly increased in phase C (Figure 5). An investigation revealed that to accommodate larger dump trucks, the road had been widened using extra earth (Figure 7).

The timing of the work coincided with the strain increase and the affected section was observed closely so that appropriate action could be taken if the strain development did not stabilize.

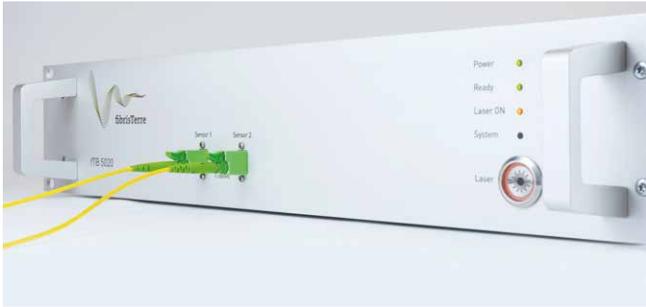
Figure 8: A fibrisTerre distributed fiber optic sensing interrogator unit

The fibrisTerre interrogator unit (based on Brillouin Optical Frequency Domain Analysis, BOFDA) provided continuous monitoring of the structure during and after construction. Detecting ground movement, creep and long-term erosion, the system reports strain and temperature changes and met the required strain measurement accuracy of 100 $\mu\epsilon$.
