Case Study:

Ground Movement and Structural Deformation Monitoring using Distributed Fiber Optic Sensing

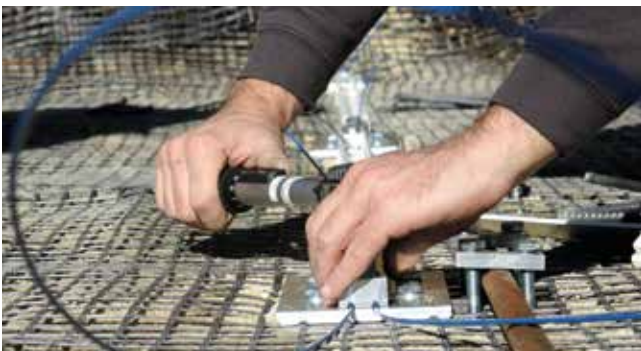
Figure 3: Attaching the fiber optic sensing cable to the geogrid

The fiber optic sensing cables were attached to geogrids using anchors and deployed at four cross-sections of the structure, at different height levels.

The strain sensing cable length was pretensioned to detect strain; the same sensing cable was used without tensioning to provide temperature compensation.

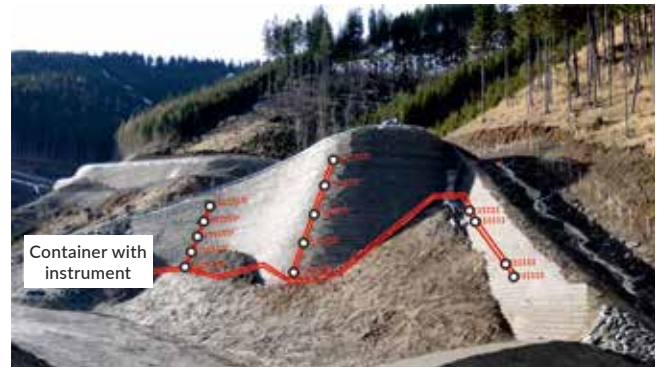
Figure 4: The geogrid and sensing cables were deployed within the earth retaining structure

At each level, a fiber optic sensing cable loop of about 2.5 km detects strain on the outward path, and temperature on the return, providing temperature compensation for the strain measurements.

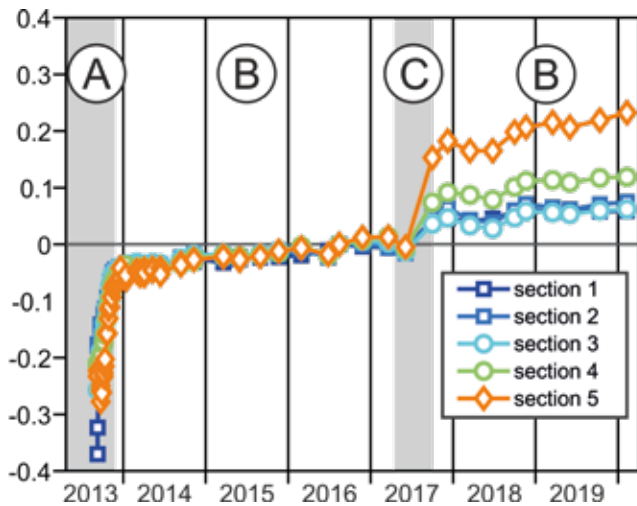
Figure 5: Strain evolution of the geogrid within the reinforced earth structure of level 2 of cross-section 1, with phases A, B and C shown

None of the threshold values were exceeded. Strain developed in three distinct phases (Figure 5), as observed in level 2, cross-section 1 (Figure 6). Phase A corresponds to the construction period of the retaining structure. The load increased as more earth layers were added. The extra weight resulted in positive strain of up to 0.4%, most of it seen in the section closest to the surface.

As expected, after construction, creep occurred as seen in phases B.

In 2017, all strain readings suddenly increased in phase C (Figure 5). An investigation revealed that to accommodate larger dump trucks, the road had been widened using extra earth (Figure 7).

Subsequently, the deformation reverted to creep (Figure 5).

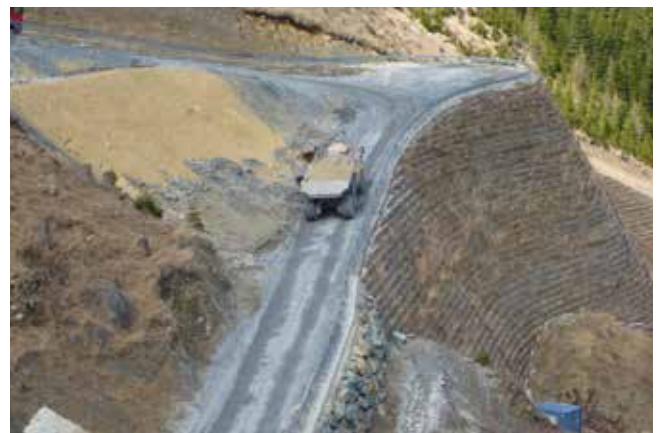
Figure 7: Adding quantities of soil to widen the access road resulted in a sudden rise in strain behind the structure

The timing of the work coincided with the strain increase and the affected section was observed closely so that appropriate action could be taken if the strain development did not stabilize.

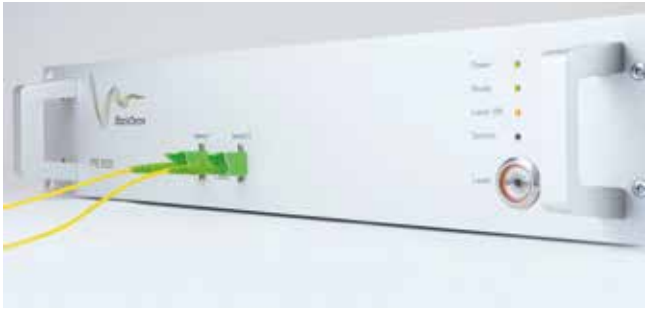
Figure 8: A fibrisTerre distributed fiber optic sensing interrogator unit

The fibrisTerre interrogator unit (based on Brillouin Optical Frequency Domain Analysis, BOFDA) provided continuous monitoring of the structure during and after construction. Detecting ground movement, creep and long-term erosion, the system reports strain and temperature changes and met the required strain measurement accuracy of $100 \mu\epsilon$.
